Manhole Inspection Summary

Manhole # S39AA_034MH

Location Address: **820 harford ct**

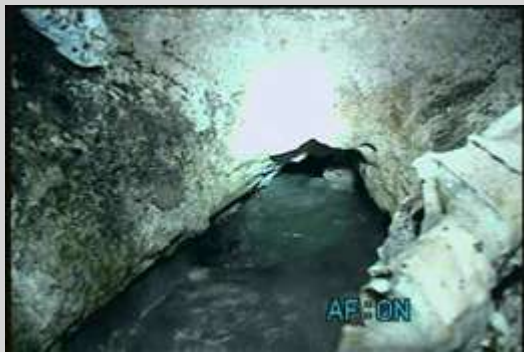
12 O'Clock Outflow

Pipe Material: **Clay** ☐ Pipe Lined

Invert Depth: 11.20 (ft.) Flow Characteristics: **Fast**

Deposits: ☒ None ☐ Mud ☐ Sludge ☐ Debris ☐ Grease

Infiltration: **None** Pipe Seal Cond: **Unknown**

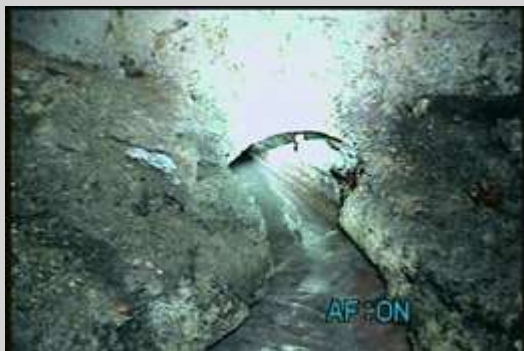
3 O'Clock Inflow

Pipe Material: **Clay** ☐ Pipe Lined

Invert Depth: 11.13 (ft.) Flow Characteristics: **Fast**

Deposits: ☒ None ☐ Mud ☐ Sludge ☐ Debris ☐ Grease

Infiltration: **None** Pipe Seal Cond: **Unknown**

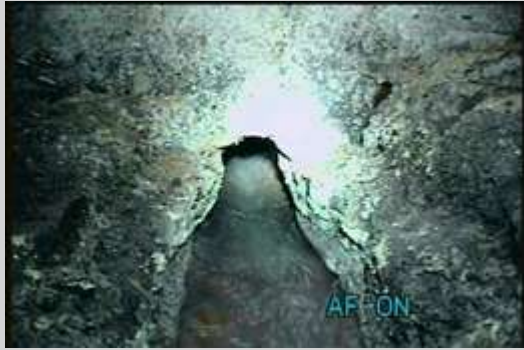
6 O'Clock Inflow

Pipe Material: **Clay** ☐ Pipe Lined

Infiltration: **None** Pipe Seal Cond: **Unknown**
